# **APPENDIX A**

APRIL 13, 2010 EPA LETTER OF APPROVAL OF GEOSTATISTICAL EVALUATION AND GEOSTATISTICAL EVALUATION

RE: Site Assessment Strategy Document for Polychlorinated Biphenyls (PCBs) Contamination at Commercial Metals Company Facility in Corpus Christi, Texas

RE: Commercial Metals Company
Corpus Christi Recycling Facility
4614 Agnes Street
Corpus Christi, Texas
Technical Justification for Site Assessment Strategy

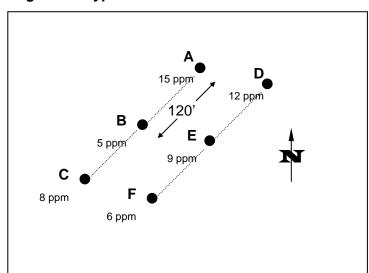
**Diagram 2: Hypothetical Data Set**

the desired direction of the variogram must be defined. As noted above, a variogram can be computed along various axes to evaluate correlation structures of the data set along different directions. For each selected direction, all pairs having the desired alignment are identified. For example, in the hypothetical example below (Diagram 2), there are 6 measurement points (A, B, C, D, E, and F). There are a total of 15 pairs (A:B, A:C, A:D, A:E, A:F, B:C, B:D, B:E, B:F, C:D, C:E, C:F, D:E, D:F, and E:F). When computing the variogram along the northeast-southwest direction, 6 pairs (A:B, A:C, B:C, D:E, D:F, and E:F) are used. For pairs having the same separation distance, the average one-half-squared difference value is computed. For example, in the diagram below, along the northeast-southwest direction, of the 6 identified pairs, four of them (A:B, B:C, D:E, E:F) are 120 feet apart with an average one-half-squared-difference of 15.875 ppm² (=.5[(15-5)²+(5-8)²+(12-9)²+(9-6)²]/4). The other two pairs (A:C and D:F) are 240 feet apart with an average one-half-squared-difference of 21.25 ppm² (=.5[(15-8)²+(12-6)²]/2). The plot of these average one-half-squared-differences versus their separation distances is referred to as the sample variogram plot².

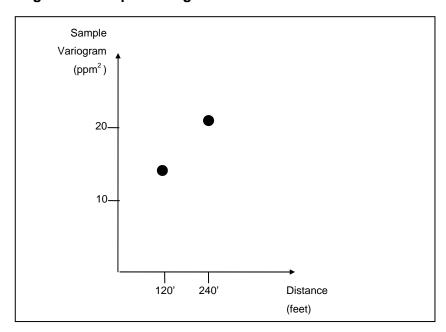
**Diagram 3: Sample Variogram Plot**

For the hypothetical example above, the sample variogram plot for the northeast-southwest direction is shown below (Diagram 3).

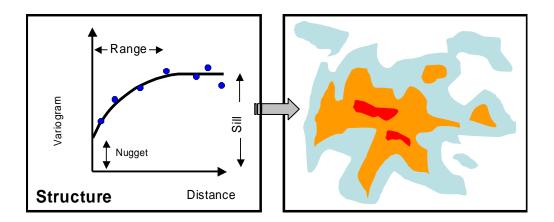
**Structured Variogram**: This type of variogram plot (see below) indicates that the nearby data points in the data set are related to each other. That is, they exhibit a spatial pattern. The spatial extent of the pattern can be calculated based on the size of the range, as shown in below. Types of environmental data that will exhibit structured variograms are old or weathered releases or plumes (see below).

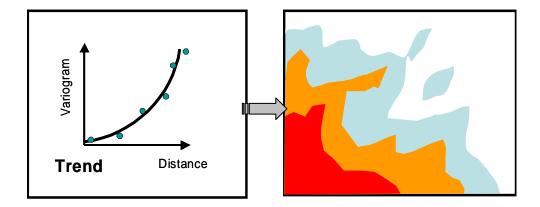
**Trend**: This type of variogram plot (see below) indicates that the measured values are gradually increasing from one zone to another. Types of data that will exhibit trend variograms are ongoing or active releases such as a leaking underground storage tank (see below).

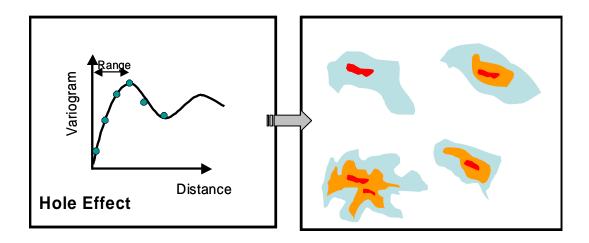
**Hole-Effect Variogram**: This type of variogram plot (see below) indicates that the related data are clustered in isolated pockets. The average size of these isolated pockets can be calculated based on the range, as shown below. Types of data that will indicate a hole-effect include areas with multiple "hot-spots" surrounded by ambient or unimpacted type data.

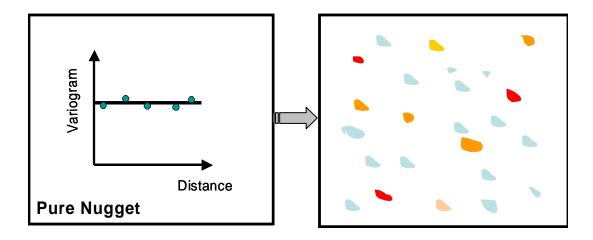
**Pure-Nugget Variogram**: This type of variogram plot (see below) indicates a case where the data are devoid of any spatial structure, i.e. completely random. Types of data that will exhibit pure-nugget variograms are ambient or unimpacted areas (see below).

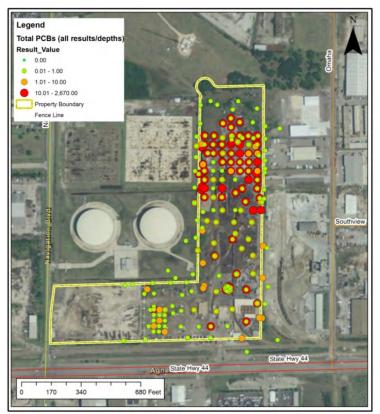
Figure 5.1.1 – Total PCBs Sample Results – mg/kg

Elevated Total PCBs concentrations (greater than 1.0 mg/kg) are predominantly present in the northern portion of the property with some isolated elevated concentrations in the central southern portion of the property. Visually, there is sample coverage throughout the entire property with dense coverage in the northern portion near the tin and automobile scrap area. Inspection of current aerial photography indicates the presence of scrap piles scattered throughout the property. The distribution and concentration gradients are illustrated on Figure 5.1.1 (below).

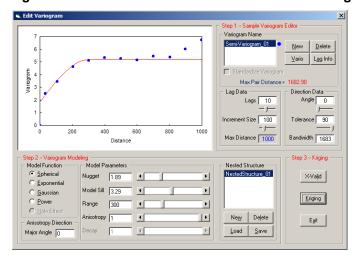
Figure 6.2-a Total PCBs 0-5 ft Omni-Directional Variogram

The omni-directional variogram of log-transformed Total PCBs 0-5 ft surface soil data is presented in Figure 6.2-a. The data set displays, similar to the 0-1 ft interval, also displays a consistent 'structured' spatial correlation. The fitted omni-directional variogram of Total PCBs also has a range of 300 feet. This demonstrates that the Total PCBs data are correlated and that concentrations can be estimated with a measurable level of statistical confidence between sample points that are no greater than 300 feet apart.

The above fitted omni-directional variogram model of log-transformed Total PCBs data is also compared to its corresponding directional sample variograms, as displayed on Figure 6.2-b. To test for directional tendencies/correlation (i.e., anisotropy), variograms are created for the following orientations: 0° (N:S) 45° (NE:SW), 90° (E:W), and 135° (SE:NW) within 22.5° tolerance windows. If any of these variograms demonstrated a greater range of correlation when compared to the omni-directional range (300 ft), then the variogram model would be adjusted to recognize the directional influences. In this case, similar to the previous 0-1 ft interval variogram, the Figure indicates that all directional scenarios variable do not display any discernable directional tendencies. Therefore, the omni-directional variogram is used.

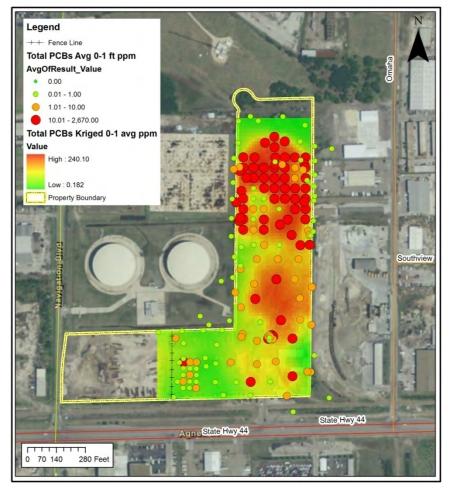
The above Figure shows that kriging concentration values were able to be determined throughout the entire study area. If the kriged contour maps result in areas with no (i.e., blank) kriged concentrations, then this would be considered an obvious or substantive data gap where supplement sampling in necessary. In this case, no obvious data gap exist for the 0-1 ft interval for Total PCBs in soil. However, the next data gap assessment involves the quality or estimation variance of the kriged concentrations that are evaluated below.

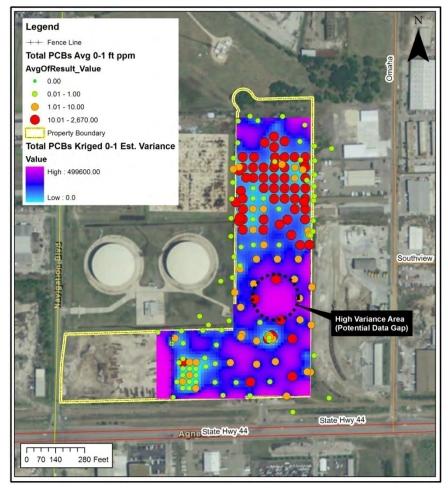
Figure 7.1.1b Total PCBs 0-1 ft Kriging Estimation Variance Map

The above Figure shows a color gradient indicating areas where low estimation variance is encountered (blue) versus areas where high estimation variance is encountered (purple). With respect to the identification of 'data gaps', a combination of several factors are considered including the high variance areas identified, the range of correlation from the variography, and the delineation/characterization performance standard. This analysis involves a certain degree of engineering judgment; as a rule of thumb, a 'data gap' is considered as a high variance area (purple) larger than ½ the original range of correlation from the variography (300/2 = 150 ft). In this case, one area meets that criteria as annotated above. This area is in the center of the Site and is identified as a potential data gap. Supplemental sampling should be considered for this area, if it is deemed appropriate in context with the delineation/characterization needs relative to risk assessment or remedial decisions. In that regard, if additional data are determined to be of value, then only one (1) additional sample would be necessary to fill the 'data gap', where the high estimation variance would be in turn eliminated.

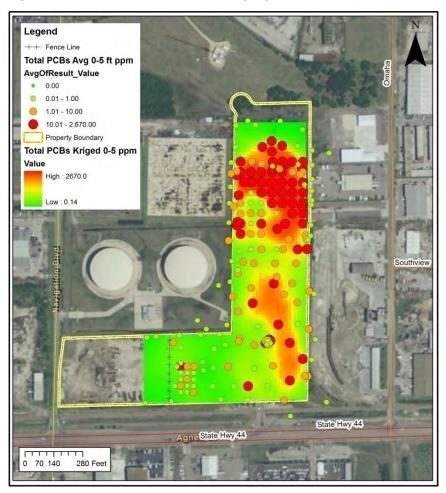
Figure 7.1.2a Total PCBs 0-5 ft Kriging Contour Map

The above Figure shows that kriging concentration values were able to be determined throughout the entire study area. Again, if the kriged contour maps result in areas with no (i.e., blank) kriged concentrations, then this would be considered an obvious or substantive data gap where supplement sampling in necessary. In this case, as with the 0-1 ft scenario, no obvious data gaps exist for the 0-5 ft interval for Total PCBs in soil. However, the next data gap assessment involves the quality or estimation variance of the kriged concentrations that are evaluated below.

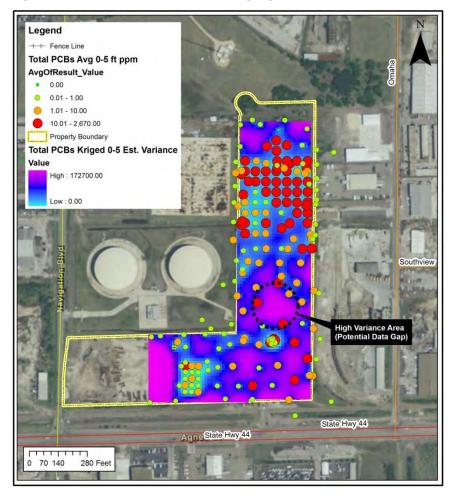
Figure 7.1.2b Total PCBs 0-5 ft Kriging Estimation Variance Map

Analogous to the 0-1 ft scenario, the above Figure shows a color gradient indicating areas where low estimation variance is encountered (blue) versus areas where high estimation variance is encountered (purple). Using the same rationale previously described with the 0-1 ft interval scenario, one area meets the 'data gap' criteria as annotated above. This is the same area identified in the previous 0-1 ft scenario. Thus, supplemental sampling should be considered for this area, and if it is deemed appropriate in context with the delineation/characterization needs relative to risk assessment or remedial decisions. In that regard, if additional data are determined to be of value, then only one (1) additional sample would be necessary to fill the 'data gap', where the high estimation variance would be in turn eliminated.

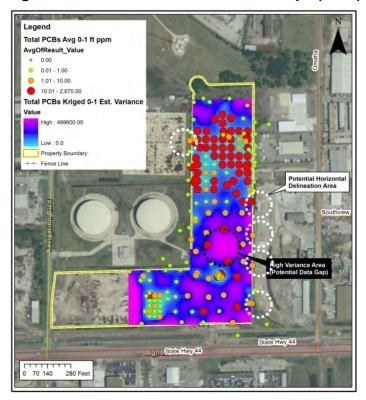
Figure 8.1 Horizontal Delineation Data Gaps (0-1 ft)

If consideration of the above results in the identification of areas that require further horizontal delineation, then the geostatistical analysis could be used to determine the location of any additional samples. Specifically, a prescribed sampling strategy based upon the 300-ft range of correlation can be determined from the Total PCBs data variography. That is, if further horizontal delineation of any area along the perimeter of the Site is desired, a prescribed sample distance of ½ the range of correlation (300/2 = 150 ft) is recommended. Sample spacing closer than 150 ft would only provide redundant data, and alternatively, any spacing greater than 300 ft would result in a data gap. Thus, any future sampling should be located based upon 150 ft spacings. The figures below (Figure 8.1 and 8.2) illustrate where potential horizontal delineation data gaps may exist with respect to evaluation of performance standard exceedances only. The final determination of specific area and sample counts would need to be based upon the previous discussion.

The geostatistical analysis did not specifically identify any true data gaps. However, one isolated area of data weakness was identified as shown in the figures in the report. Thus, only this area is recommended for potential supplemental sampling. While addressing this particular data weakness is not critical from the perspective of completing delineation within the Site boundary, additional concentration data within this area would provide greater resolution to support risk characterization for the Site.

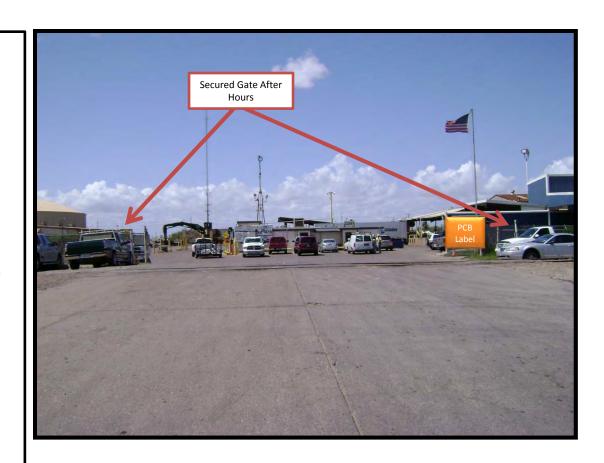
# Photograph NO. 1

**Sign Description:** A PCB label (6"x 6") will be posted at the facility entrance (see Figure 3 for approximate

placement location).

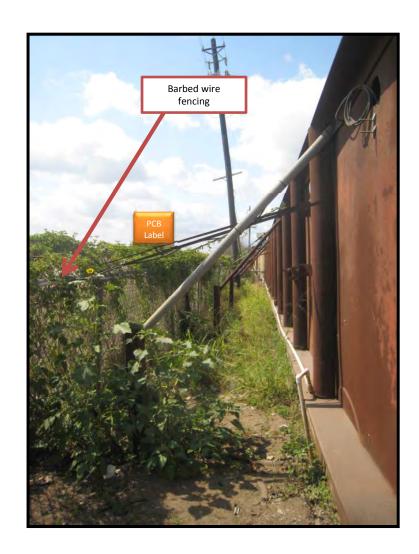
**Sign Description:** A PCB label (6"x 6") will be posted on the outside fence line (see Figure 3 for approximate

placement location).

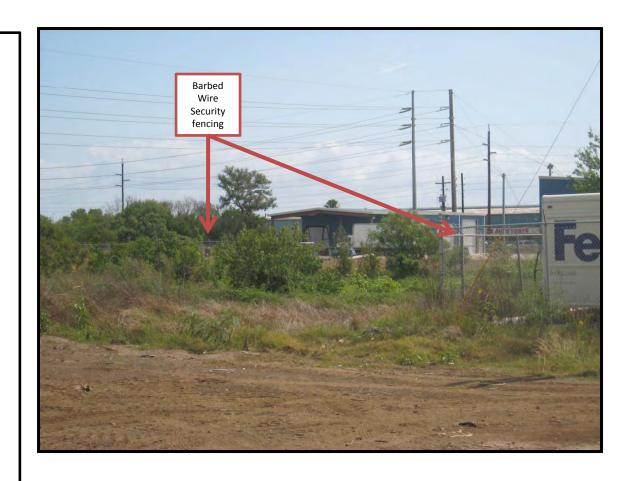
**Security Fence Description:** Access is limited from the north due to thick brush and vegetation.

**Sign Description:** PCB labels (6"x 6") will be posted on fence posts near northern property line (see Figure 3 for approximate placement location).

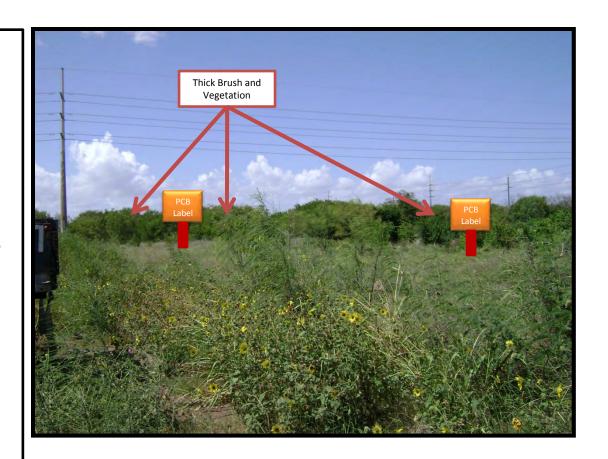
**Security Fence Description:** Barbed wire security fencing along western portion of property boundary. Access is limited from the north due to thick brush and vegetation.

**Sign Description:** A PCB label (6"x 6") will be posted on a fence post near northern property line (see Figure 3 for approximate placement location).

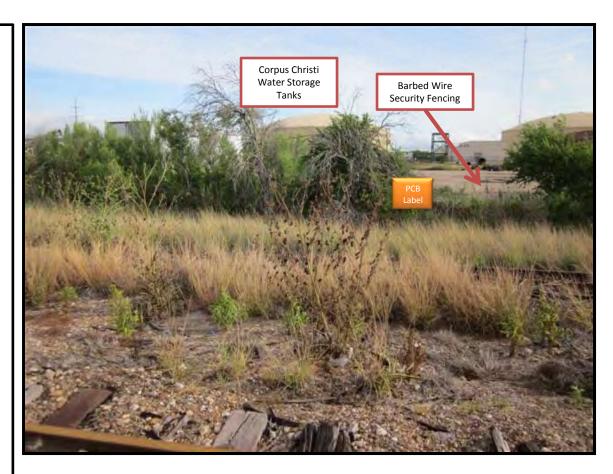
**Sign Description:** A PCB label (6"x 6") will be posted on the outside fence line (see Figure 3 for approximate

**Date:** 5/11/11

**Photo Direction:** N

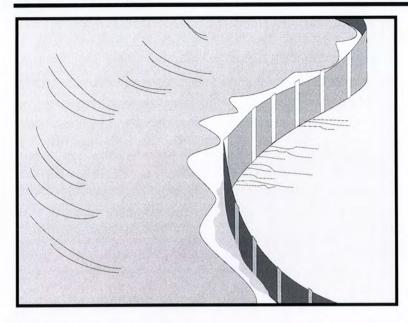
Silt Fence SE-1

- Do not use in locations where ponded water may cause flooding.
- Do not place fence on a slope, or across any contour line. If not installed at the same elevation throughout, silt fences will create erosion.
- Filter fences will create a temporary sedimentation pond on the upstream side of the fence and may cause temporary flooding. Fences not constructed on a level contour will be overtopped by concentrated flow resulting in failure of the filter fence.
- Improperly installed fences are subject to failure from undercutting, overlapping, or collapsing.
  - Not effective unless trenched and keyed in.
  - Not intended for use as mid-slope protection on slopes greater than 4:1 (H:V).
  - Do not allow water depth to exceed 1.5 ft at any point.

- The trench should be backfilled with compacted native material.
- Construct silt fences with a setback of at least 3 ft from the toe of a slope. Where a silt fence is determined to be not practicable due to specific site conditions, the silt fence may be constructed at the toe of the slope, but should be constructed as far from the toe of the slope as practicable. Silt fences close to the toe of the slope will be less effective and difficult to maintain.

- Repair undercut silt fences.
- Repair or replace split, torn, slumping, or weathered fabric. The lifespan of silt fence fabric is generally 5 to 8 months.

- Silt fences that are damaged and become unsuitable for the intended purpose should be removed from the site of work, disposed of, and replaced with new silt fence barriers.
